Manhole Inspection Summary

Manhole # S11CC2008MH

Location Address: **5814 GREENSPRING AVE**

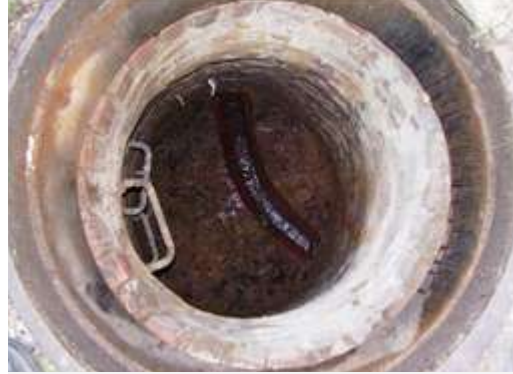
Top View

Frame leaks. Frame offset. Adjustment deterioration and infiltration. Evidence of surcharge - Bench debris.

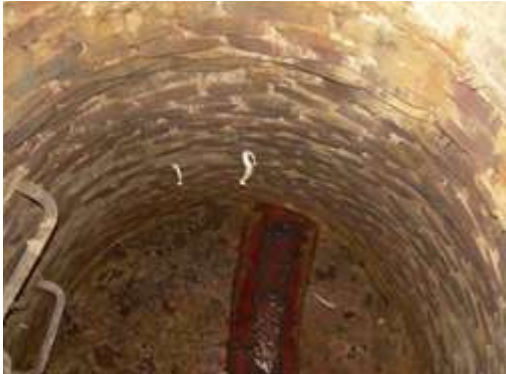
Defect

Mushrooms.

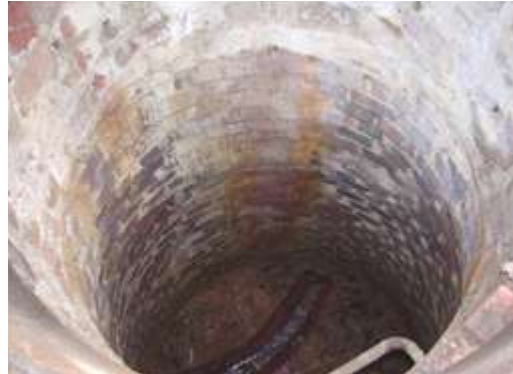
Defect

Adjustment and Corbel infiltration.

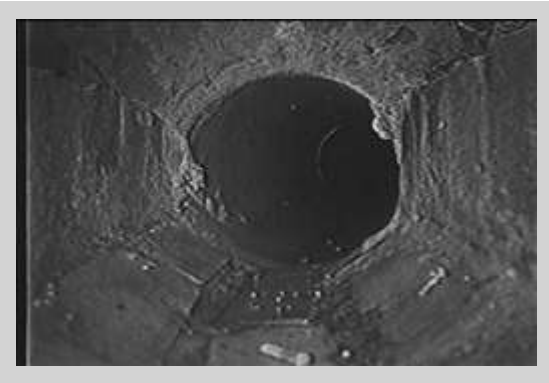
8 in. Circular Gravity Sewer Pipe Out @ 12 O'Clock

Deposits: ☐ None ☐ Mud ☐ Sludge ☐ Debris ☒ **Grease**

Silt Depth: **0** (in.) Deposits Extent: **Light**

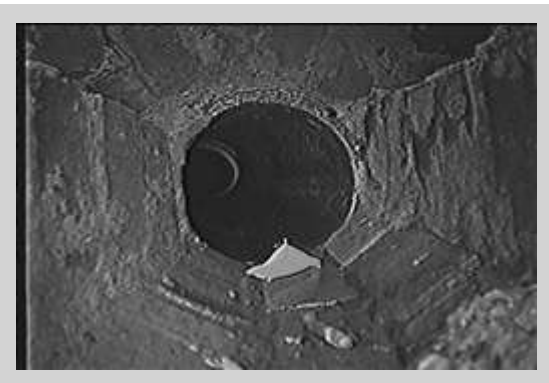
6 in. Circular Gravity Sewer Pipe In @ 5 O'Clock

Deposits: ☐ None ☐ Mud ☐ Sludge ☐ Debris ☒ **Grease**

Silt Depth: **0** (in.) Deposits Extent: **Light**
